MEC6905 Mini Project (group)

Fretting Corrosion in Modular Hip Joints: Critiquing Standard Practice ASTM F1875

January 2014

A report submitted by iT-CDT students from the University of
Sheffield and the University of Leeds

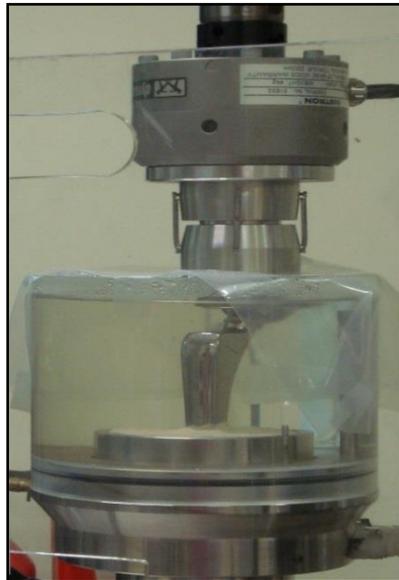
Figure 1-1 - Complete assembly of method I (adapted from [1]).

The basic purpose of method 1, which prescribes a long term test, is to provide a standard set of guidelines to determine the amount of damage by measurement of the corrosion product and debris which are generated as by-products from the fretting corrosion phenomenon[3][1]. This method simultaneously evaluates the fatigue strength of the stem in conjunction with standard practice F1440 (i.e. standard practice for cyclic fatigue testing of metallic stemmed hip arthroplasty femoral component without torsion) and the debris produced by fretting corrosion. A servo hydraulic machine (Instron) is used for mechanical testing purpose and the stemmed femoral components are loaded cyclically as mentioned in practice F1440 [3], as shown in Figure 1-1.

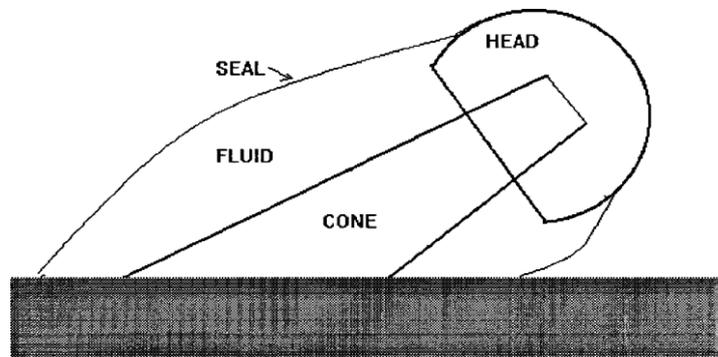
Figure 1-2 - Method 1 pictographic representation of rig set up (adapted from[3]).

environmental containment chamber by immersion of the entire device. The head cone interface is enclosed in an elastomeric sleeve, having electrolyte solution surrounding it, but the contact area between the femoral head and low friction thrust bearing is not exposed to the electrolyte solution, as shown in Figure 1-2.

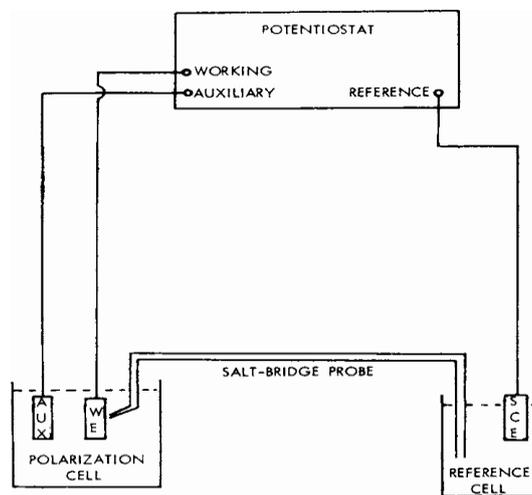
Figure 1-3 - Wiring diagram of electrochemistry rig.

In procedure A, a counter electrode along with the saturated calomel electrode with luggin probe or salt bridge is used as a reference reference electrode, which measures changes in corrosion potential with the help of an electrometer. The polarization characteristics are measured with a potentiostat, as shown in Figure 1-3 [3].

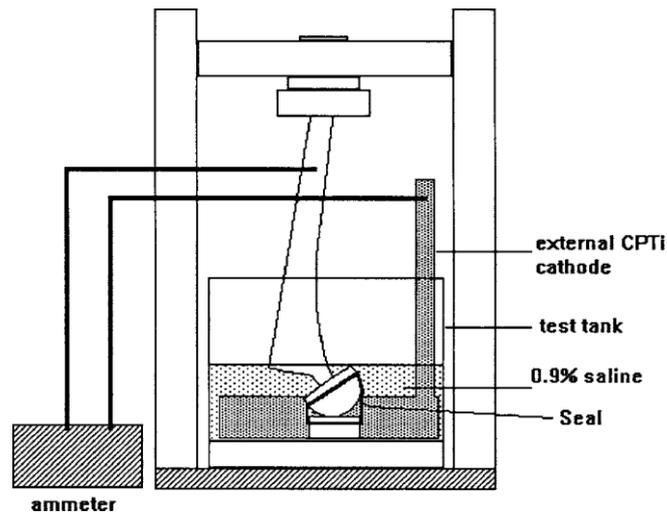
Figure 1-4 - Method II procedure B, set up for measuring fretting corrosion current (adapted from[3]).

In procedure B, a counter electrode is immersed in the solution and an ammeter is connected between the test specimen and the counter electrode. Difference in current measured before and during cyclic loading shows the fretting corrosion current between the specimen (anode) and the metal bar/sheet (cathode), as shown in Fig. 4 [8]

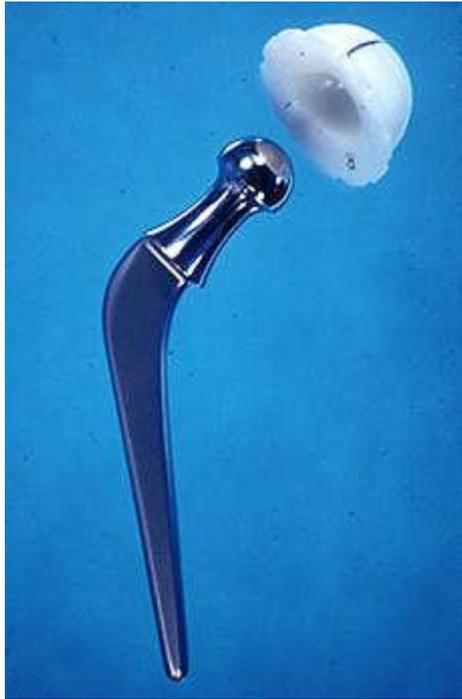
Figure 2-1 - An image of a Charnley Hip Design [6].

THA is the final solution to severe osteoarthritis. Osteoarthritis is a disease which causes dramatic reduction in articular cartilage thickness on interfacing joint surfaces. The body is unable to replicate articular cartilage and so this condition is progressive and typically results in bone on bone contact. Since bone has effective nerve throughout this leads to extreme pain and limited mobility[4]. There are two main surgeries performed to alleviate this pain in the hip joint, total joint replacement and partial joint replacement/resurfacing. Total joint replacement requires the removal of the damaged joint interfaces and their replacement with artificial versions. This practice is widely accredited to John Charnley, in November 1962, however there were less successful attempts conducted dating back to 1891. Charnley created the metal on polymer implant style still used today, he utilised a stainless steel stem with a polyethylene acetabular cup.[5]

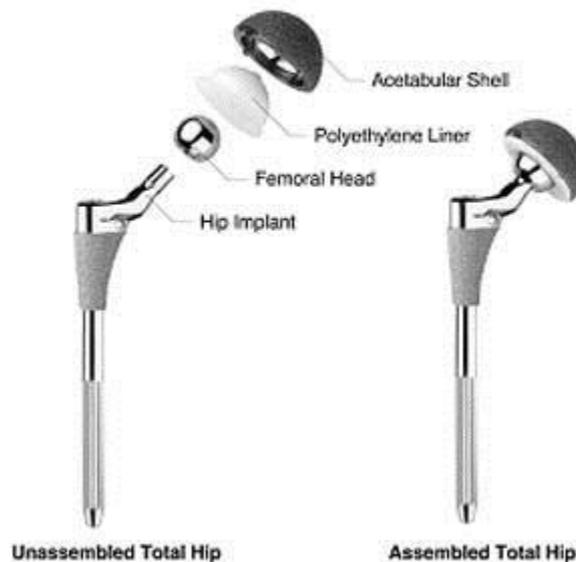
Figure 2-2 - Modular Hip Replacement illustrating the components that compose a standard modular device [9]

As stated above MHA's are when the replacements are made up of multiple components, not just femoral portions and cup sections. They usually consist of removable femoral heads and replaceable acetabular inserts (or liners). The stem and the acetabular cup are both either cemented or otherwise bonded to the underlying bone. MHA's are designed such that these elements are unaffected if a revision surgery becomes necessary, therefore they are designed to be long lasting. Currently the only materials that can support the mechanical loads that such elements require are made of metals, typically either stainless steel or cobalt chromium alloy although there are also titanium alloy stems available. The femoral head has to transfer this mechanical load from the acetabular cup and so is typically constructed of either a metal or a ceramic.[5]

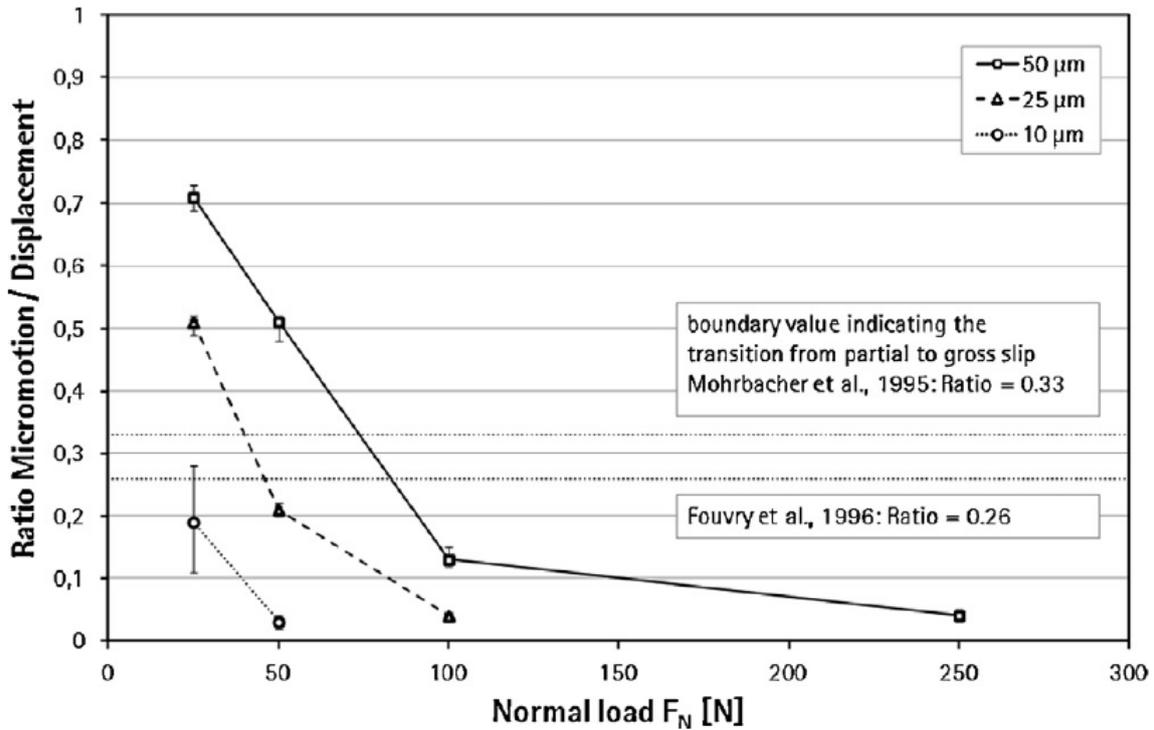
Figure 2-3 - Ratio between sliding distance (micromotion) and applied displacement in relation to load (adapted from[17]).

the displacement range investigated. The ratio between sliding distance (micromotion) and the applied displacement indicated the transition between regimes. Figure 2-3 shows how this ratio relates to load; a load range of 25-100N (corresponding to 400-630MPa) was required to change regimes.

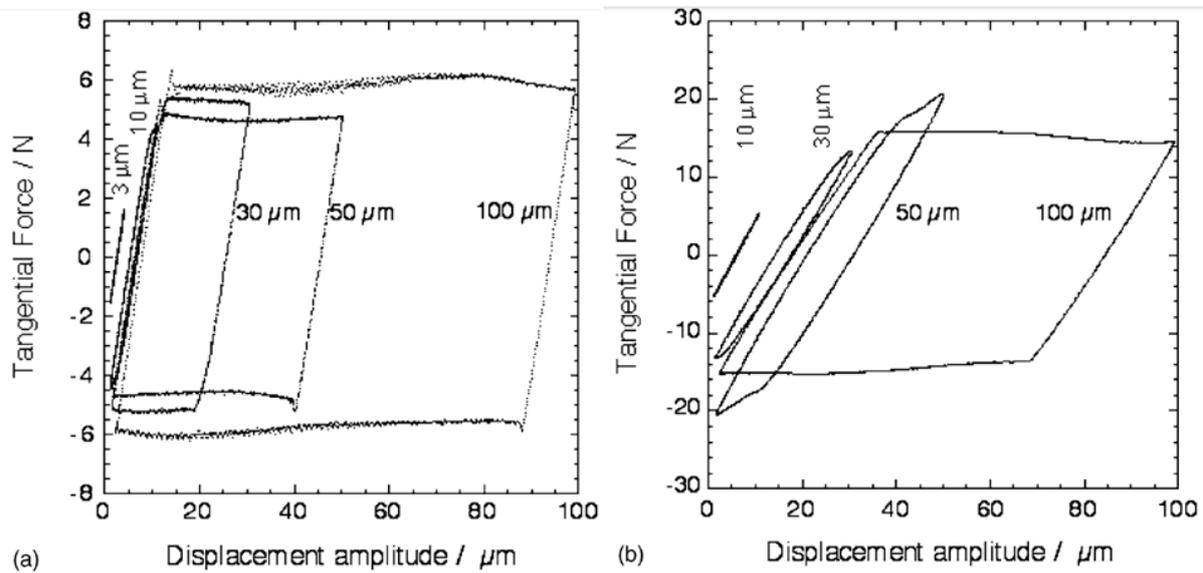
Figure 2-4 - Several displacement amplitudes are overlaid on the same force-displacement plot for comparison. Tests in (a) were at 910MPa p_{max} and (b) 1314MPa (adapted from [19]).

held constant at 910MPa but displacement amplitude varied. For a small deviation in amplitude, the fretting regime can be seen to change: 3 μ m stick; 10 μ m stick-slip; >30 μ m slip. Figure 2-4(b) shows a larger displacement is required to produce similar trends when under a higher constant pressure (1314MPa).

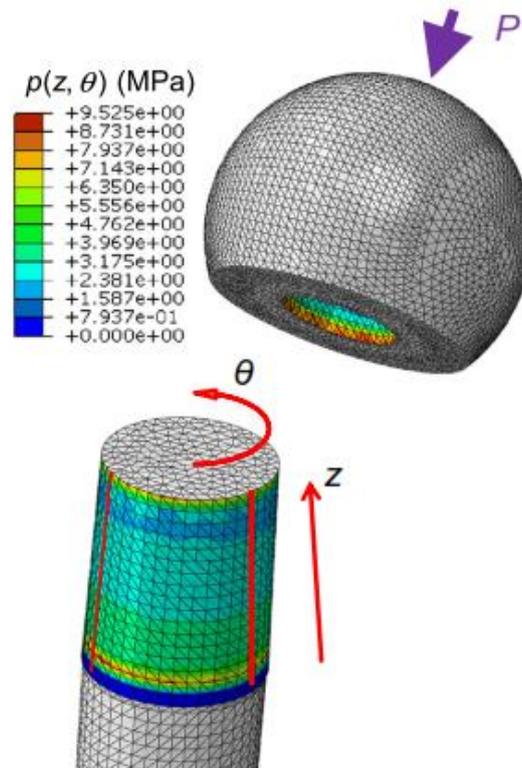
Figure 2-5 - An FEA model of the head-taper interface [23].

Zhang et al conducted an FEA investigation to determine the peak contact pressure found in a cylindrical contact. A 3D model was created, Figure 2-5, to model two slip regimes.

Zhang et al. then conducted physical fretting tests using a 6mm radius pin to create a maximum contact pressure of 68MPa, which was determined from the FEA analysis results, shown in Figure 2-5 [23].

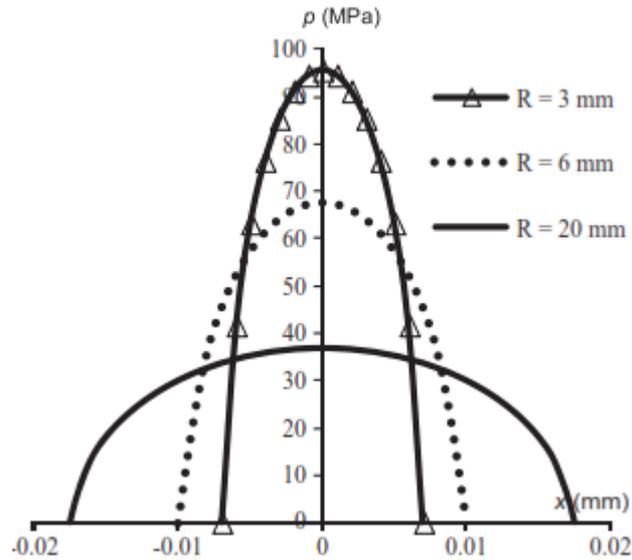
Figure 2-6 - Hertzian solution indicated contact pressure [23].

The slip regimes investigated were gross slip and partial slip, with a corresponding normal load of 500N and 1000N. The half stroke for the gross slip regime was 40 μ m and for the partial slip was 22.6 μ m. Three pin radii were simulated, 3mm, 6mm and 20mm. Figure 2-5 shows that the maximum contact pressure decreased with increasing pin radius.

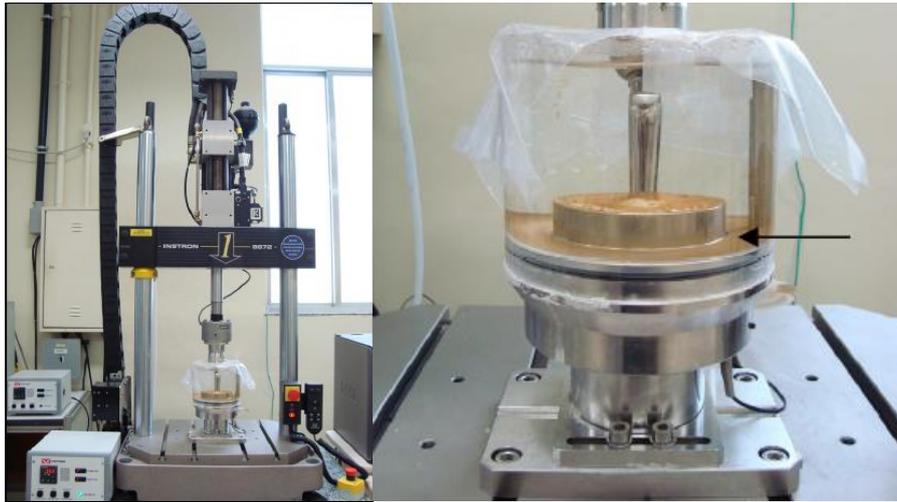
Figure 2-7 - ASTM method I test set-up, also showing significant corrosion product after 10 million cycles (adapted from [1]).

Caminha and Roesler conducted tests in accordance to ASTM F1875 and documented their experimental procedure and rig design neatly [1], although it looks like they used significantly more fluid than the “5-100ml” recommended in ASTM F1875, as Figure 2-7 shows in a photo of their experimental set-up. This design appears more practical than the “elastomeric sleeve” recommended in ASTM F1875 which is used in older studies, particularly when it comes to extracting fluid for later analysis.

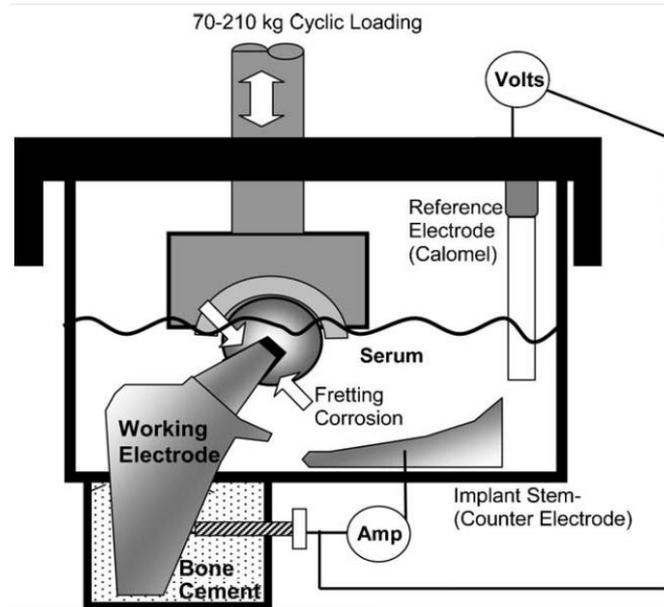
Figure 2-8 - ASTM method II procedure B set-up (adapted from [27]).

Hallab et al [27] cut their femoral stems to form coupons which were cemented in place as per ASTM F1875 Method II Procedure B and ASTM F1440, then used the offcut stem as the counter electrode, as Figure 2-8 shows. Their test procedure differed in that they used 100% FBS and 2Hz loading frequency as “a compromise from lower, more physiological rates to permit a practical testing time period”.

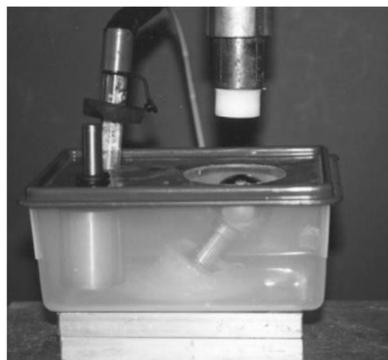
Figure 2-9 - The lunchbox method of containment (adapted from [2]).

Other studies have used parameters based on ASTM F1875 Method II, such as Schaaff et al [28], though their set-up was for a sphere-on-plate test. Goldberg and Gilbert tested custom made modular neck taper components against femoral head in a set-up similar to ASTM F1875 method II [2]. The necks had threaded holes manufactured into them to attach to the test rig. The fluid containment method was simple yet effective, as Figure 2-9 shows.

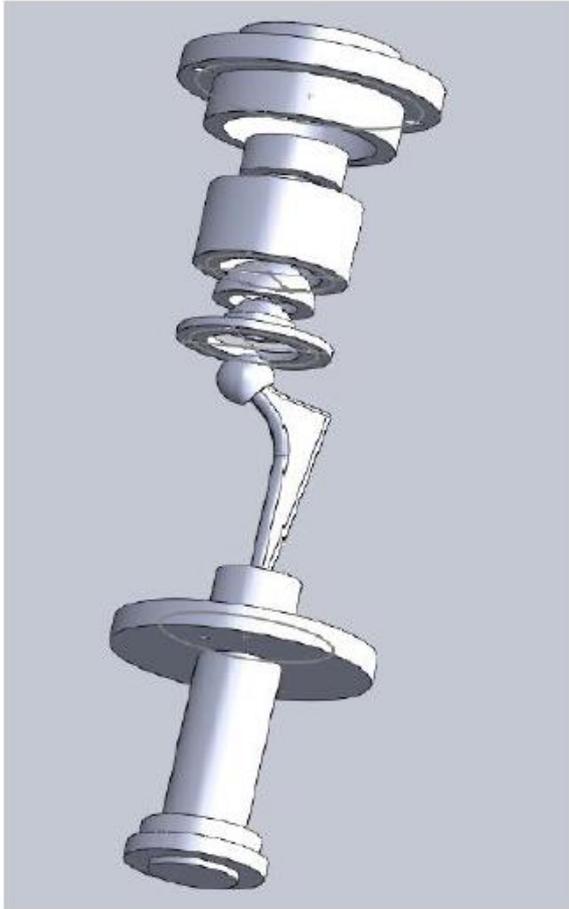
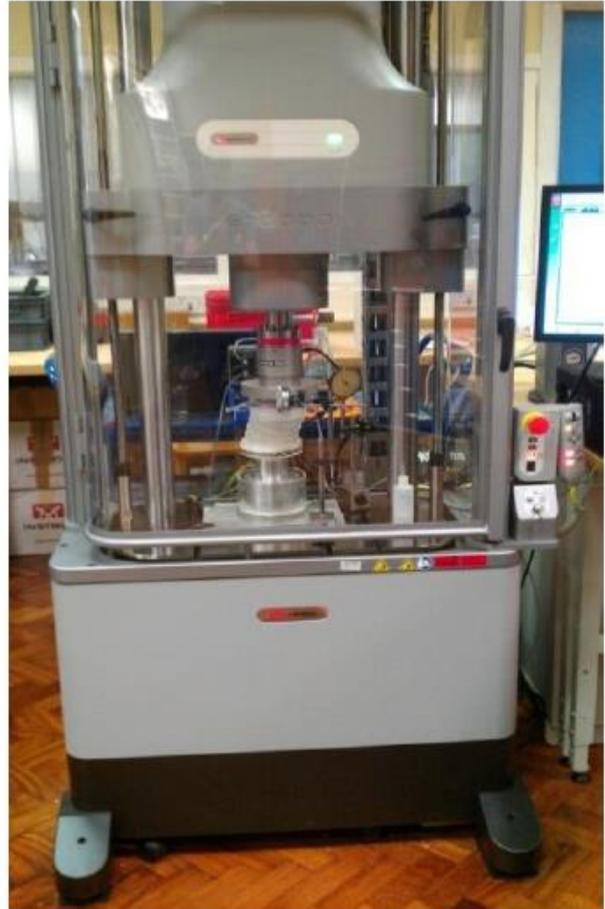
Figure 4-1 – Schematic and photo of the previous upright rig which were modified (adapted from [29]).

In a previous study conducted at the University of Leeds, a test method was developed based on ISO 7206-4, which is similar to ASTM F1875 Method I [29]. This test rig is available for modification to the current study's needs. A diagram and photo in Figure 4-1 show the test set-up.

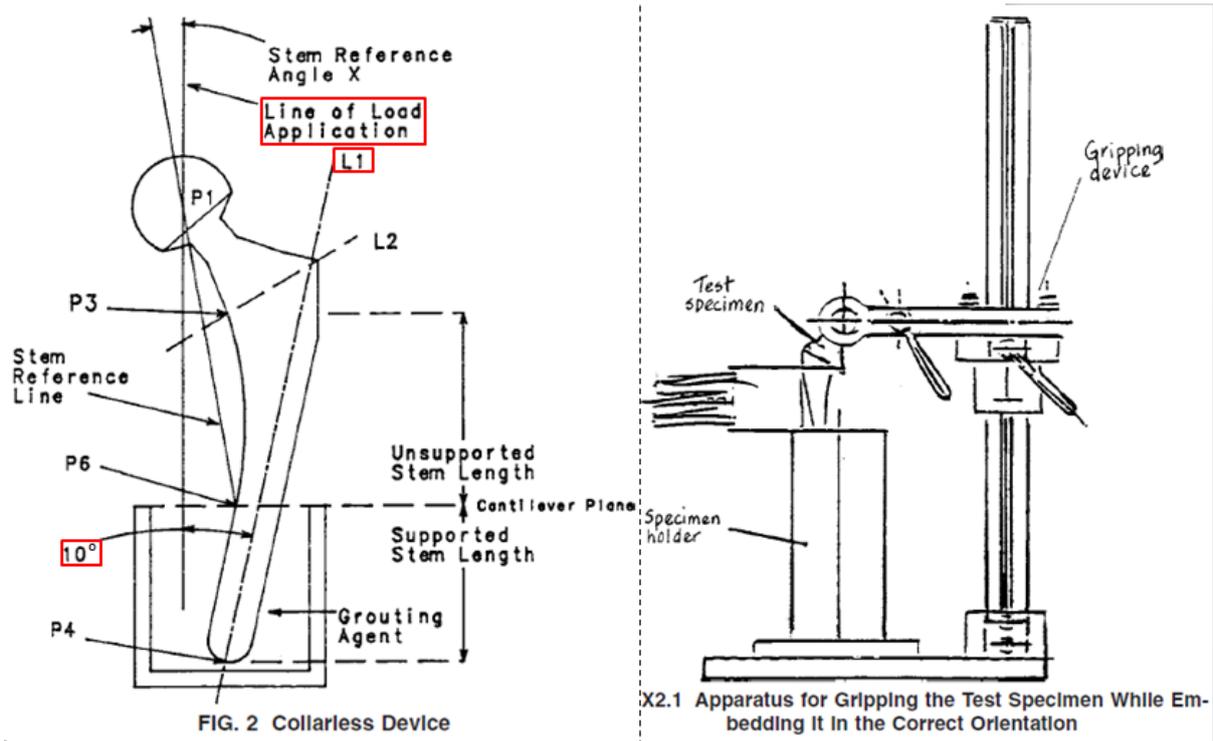
Figure 4-2 - The 10° angle at which the stem should be tested at for ASTM F1875 Method I and a suggested gripping device design (adapted from [30]).

The load machine is an Instron E10000. Stems used in the current study were high nitrogen stainless steel DePuy C-Stem AMT (size 4) standard offset, heads were LC CoCrMo DePuy ARTICUL/EZE M 36MM +1.5. Most test rig materials in contact with the test solution were bio-inert and non-corroding so as not to affect the sterility of test conditions. Low dose antimicrobials were also used, as recommended by ASTM F1875. ASTM F1875 specifies in section 6.2 “Specimen Mounting Devices, Method I” that “modular hip and stem components shall be set up as described in Practices F1440”. Hence ASTM F1440 section 8.1 details that the components should be mounted at an angle 10° off the line of load application. ASTM F1440 also includes a diagram to illustrate the mounting angle and a design of a suggested gripping device to achieve this angle when setting the stem in a suitable grouting medium, as reproduced in Figure 2-3 here.

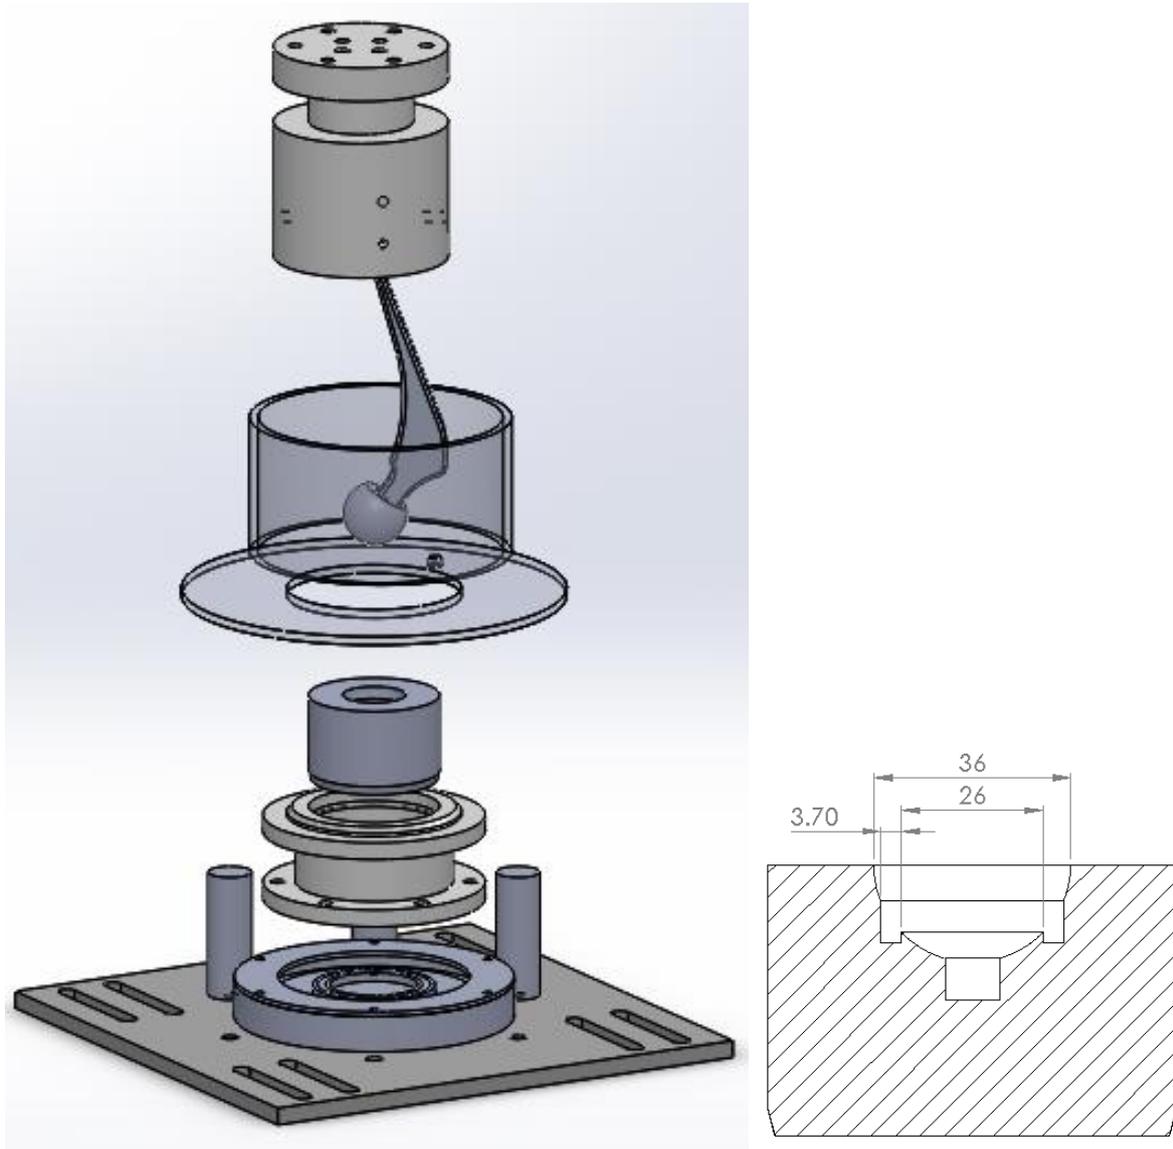
Figure 4-3 – Schematic of the method I test rig manufactured and detail of the seal design at the lower loading face.

and any surfaces which came in contact with test fluids, since grease from skin can affect electrochemistry readings. Figure 4-3 shows a schematic of the rig, which includes a thrust bearing at the base of the design to minimise bending moments, although this was not specified in ASTM F1875. Figure 4-3 also shows the O-ring seal design for the immersed loading face in accordance with ASTM F1875.

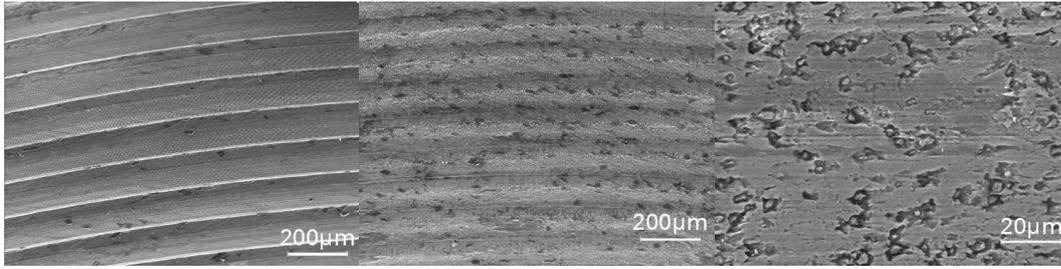
Figure 6-1. From left to right -SEM image of an unworn manufactured taper surface, SEM image of worn taper surface at the same magnification, SEM image of worn taper surface at a higher magnitude showing the presence of pits within the surface[37].

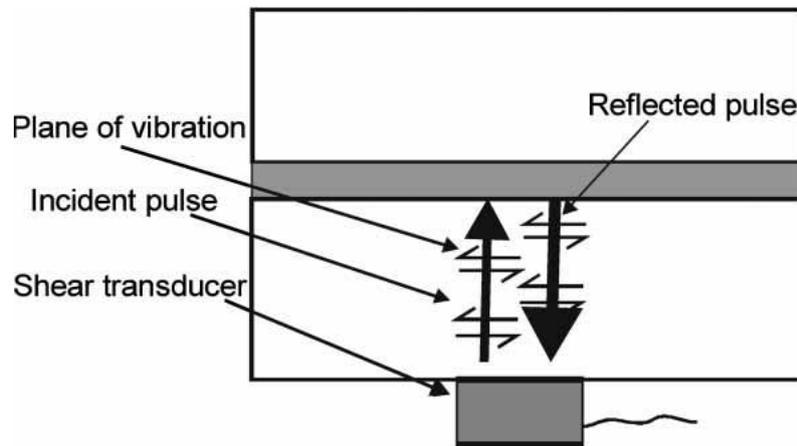
Figure 6-2: Schematic diagram of shear wave ultrasonic measurement of viscosity of a thin fluid film[39].

Fluid viscosity is an important physical property of fluid between load bearing contacts as viscosity determines the thickness of the separating film between the bearing surfaces and thus the degree of wear and load carrying capacity[39]. The viscosity of each fluid was taken using a novel experimental ultrasonic technique for measuring viscosity in real time. When an ultrasonic wave is directed on a solid liquid interface the proportion of the wave that is reflected is related to the viscosity of the liquid[39], see Figure 6-2. A shear wave at 10^6 (s^{-1}) was used, this shear is known to be experienced between the acetabular cup and femoral head during normal walking, although the shear experienced within the taper interface is unknown. It is anticipated that the shear rate within the contact will determine the viscosity of the liquid within the interface and thus affect the wear rate and separation of the taper from the head.

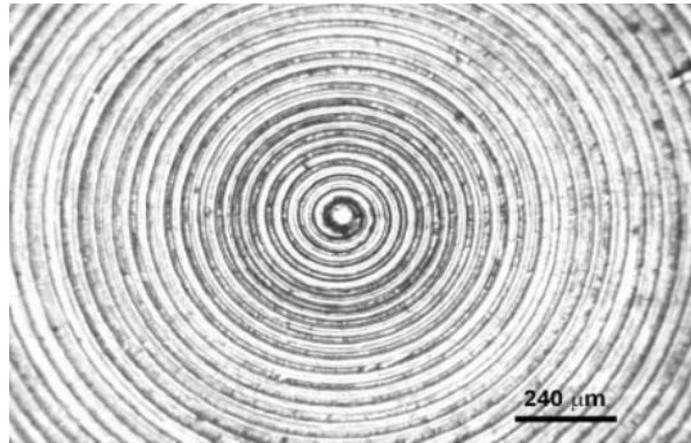
Figure 7-1 - An optical microscopy image of marks caused by mechanical polishing [26].

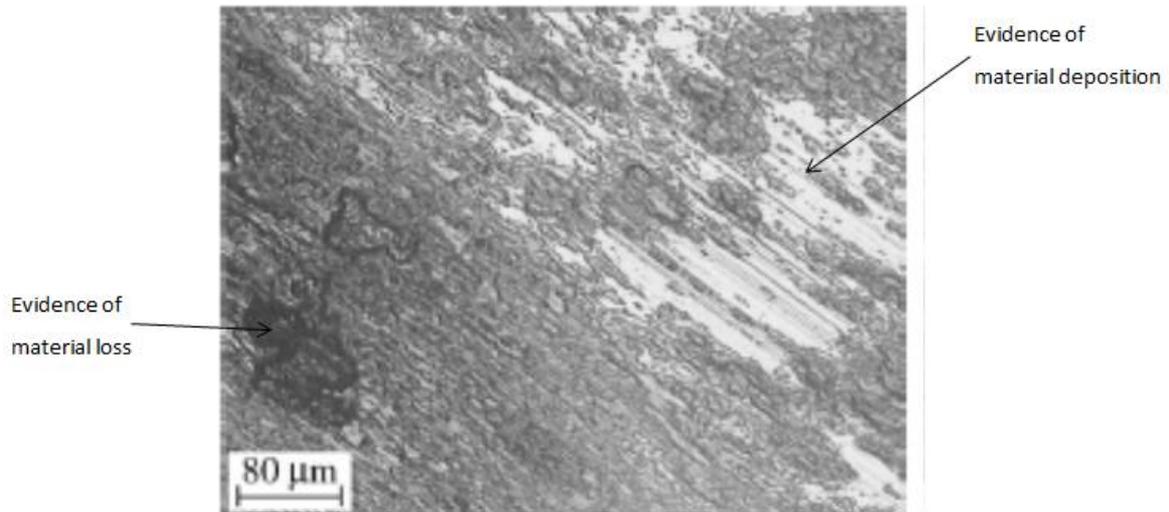
Figure 7-2-An optical microscopy image showing adhesive wear [43]

Varenberg et al performed a ball on plate fretting test, without a medical focus, which they analysed using optical microscopy. When presenting their results a detailed description of what wear mechanisms caused which parts of the image was provided. It is claimed that very bright portions of the image correspond to wear debris, as the surface is higher there than for the rest of the image. It is also explained that the dark regions are areas where wear has occurred, as the surfaces are farther away there. If these occur in “clumps” it is probable that the primary wear mechanism is adhesion and the debris has been released by fretting fatigue. If there are light and dark lines it is probable that the main wear mechanism has been abrasion. Figure 7-2 and Figure 7-3 explain this more clearly. [43]

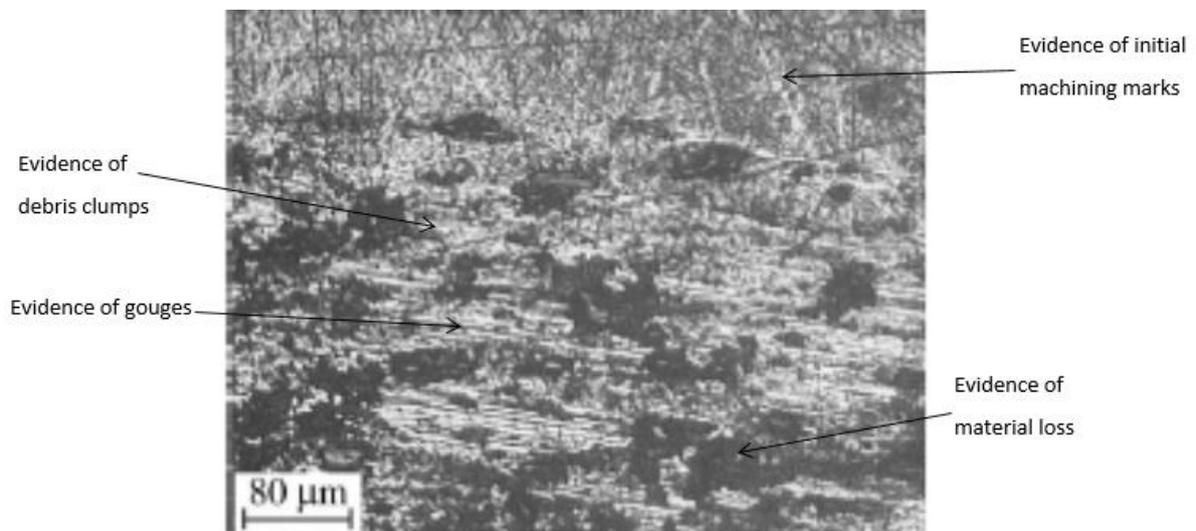
Figure 7-3 - An optical microscopy image showing abrasive and adhesive wear and machining marks. [43]

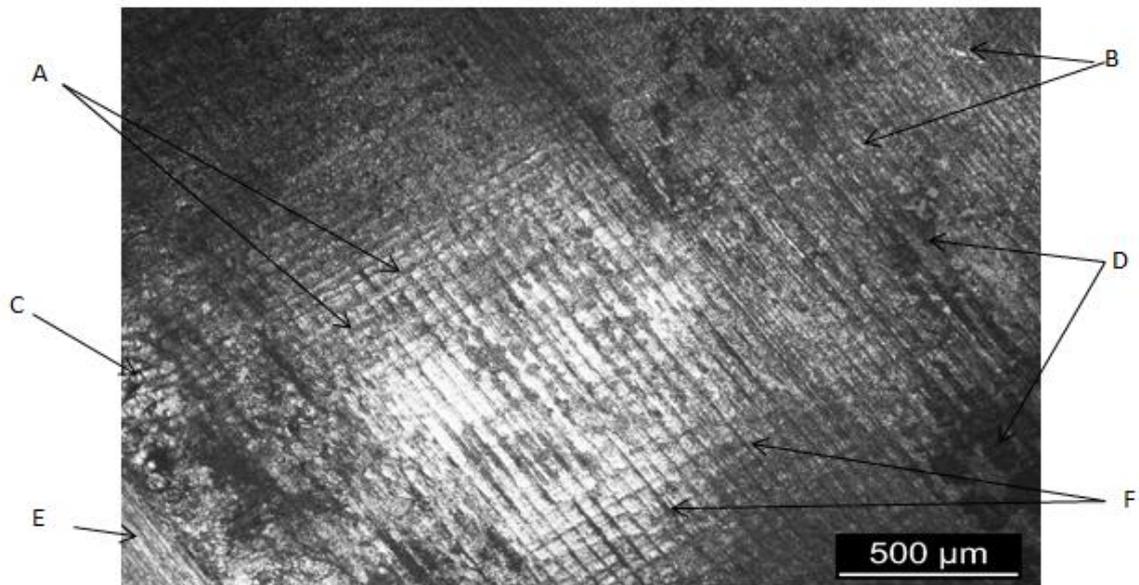
Figure 7-4: An optical microscope image of the taper base from the 1 year retrieved implant

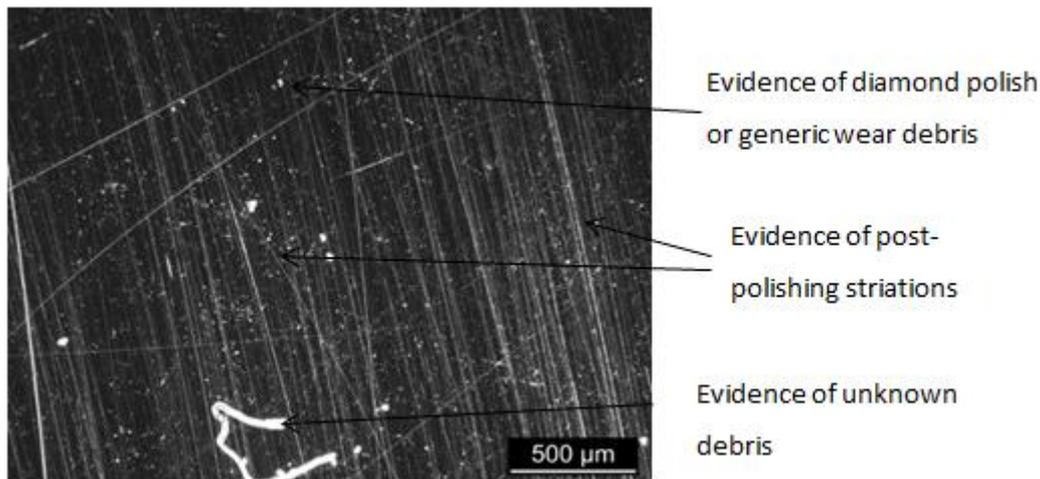
Figure 7-5: An optical microscopy image of a post-polished coupon surface

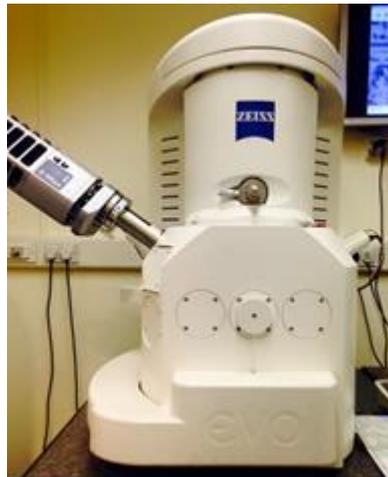
Figure 8-1: Carl Zeiss Evo scanning electron microscope used in this investigation.

A Carl Zeiss Evo SEM, seen in Figure 8-1 below, was used to analyse various explants as the SEM analysis method produces high resolution and high magnification images.

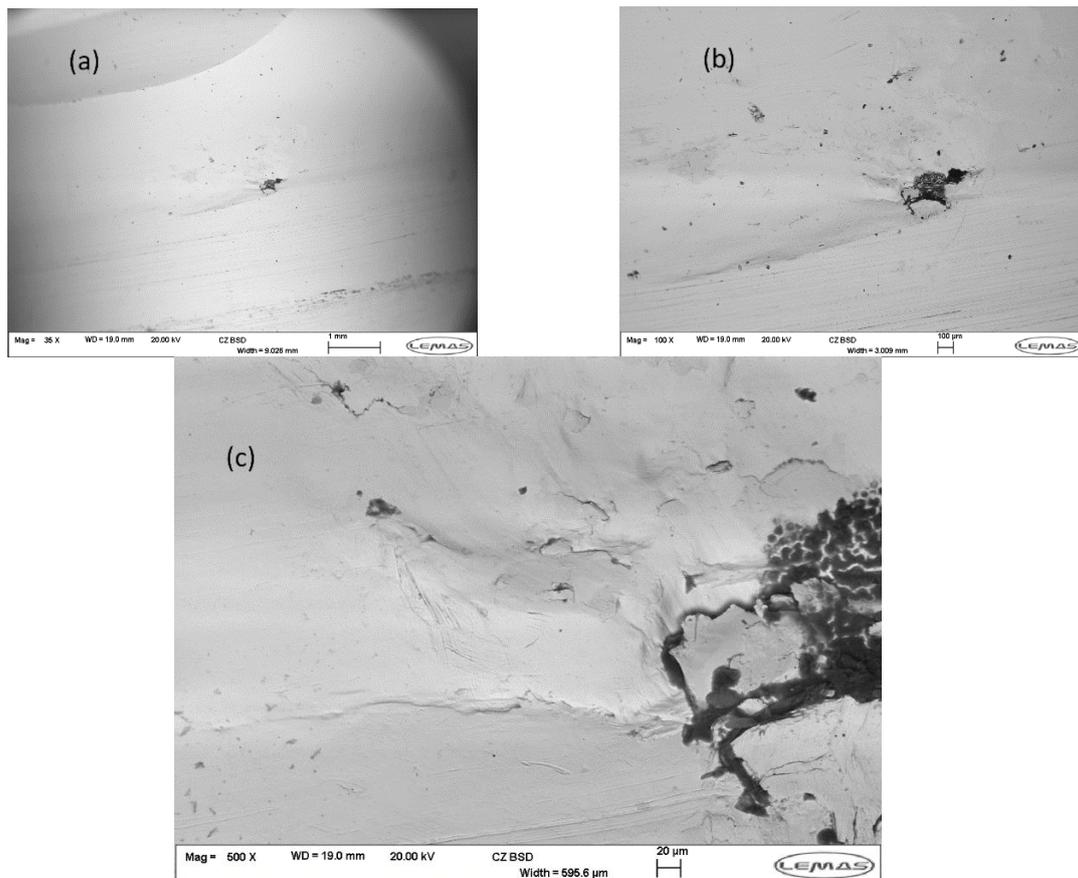
Figure 8-2: SEM images of sample taper of 8.7 year explant showing wear scar, (a) at 35x, (b) at 100x and (c) at 500x magnification

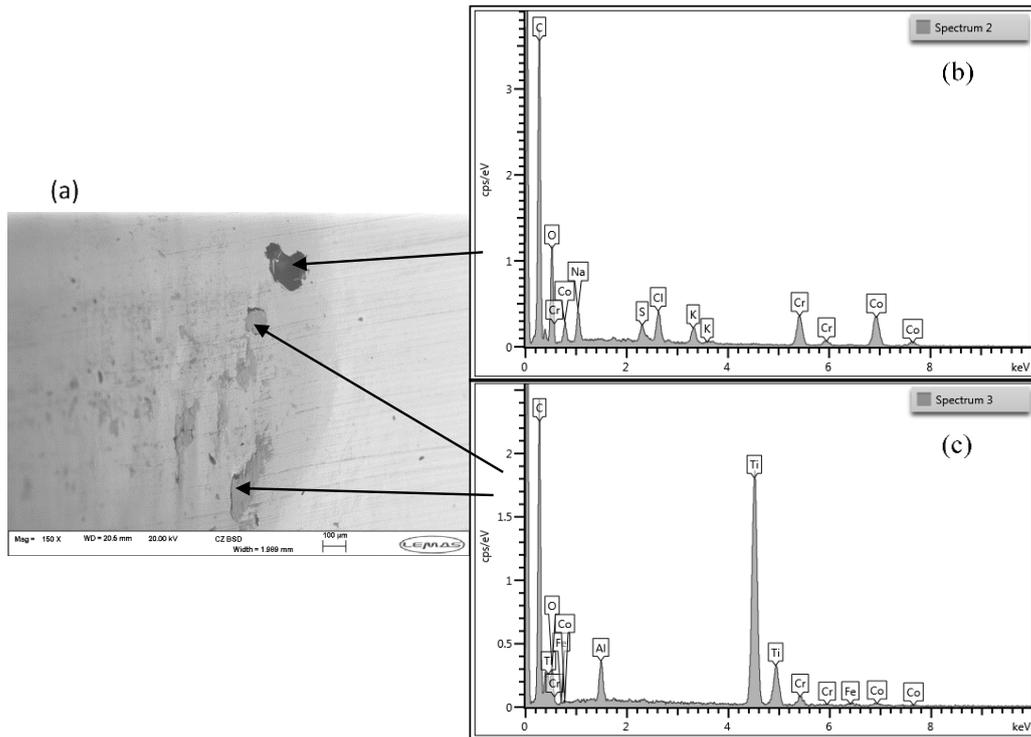
Figure 8-3: (a) SEM image of on sample taper of 8.7 year explant along with (b), (c) EDX spectrum at various spot

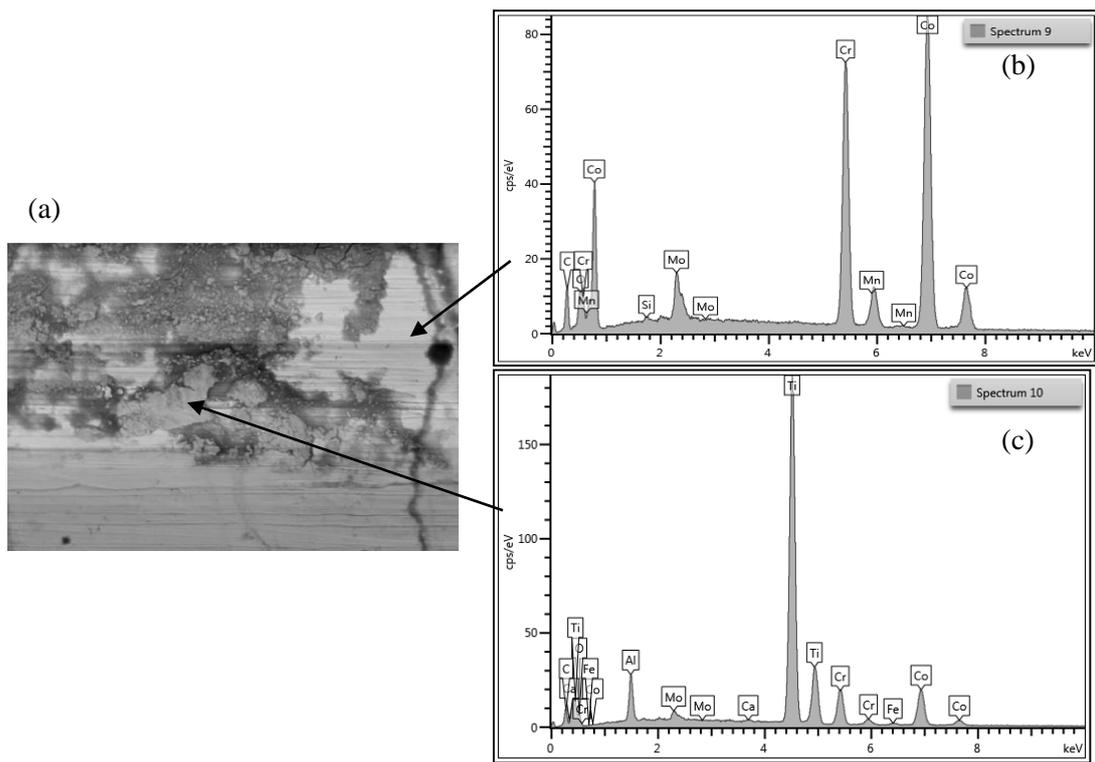
Figure 8-4: (a) SEM image of on sample taper of 8.7 year explant along with (b), (c) EDX spectrum at various spot

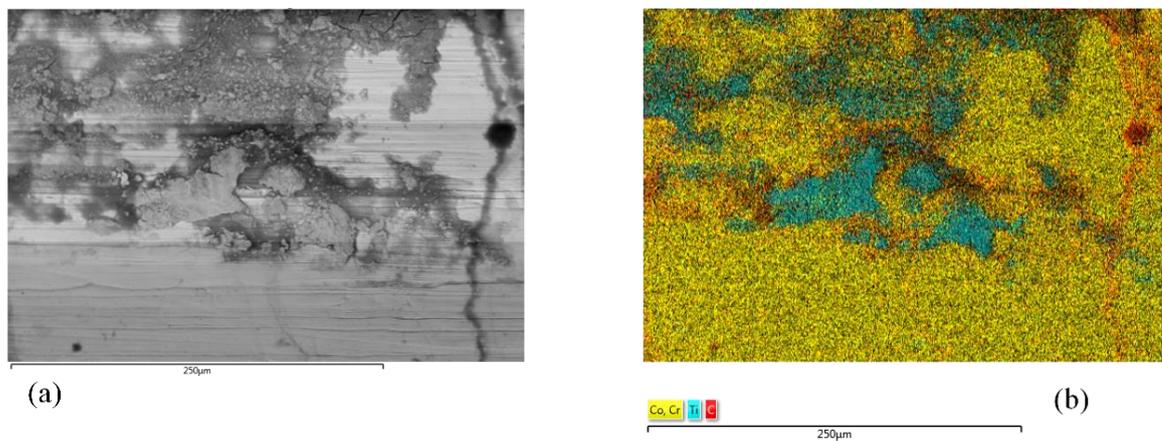
Figure 8-5: (a) SEM image of on sample taper of 8.7 year explant and (b) EDX mapping of Co, Cr (yellow); Ti (blue) and C (red).

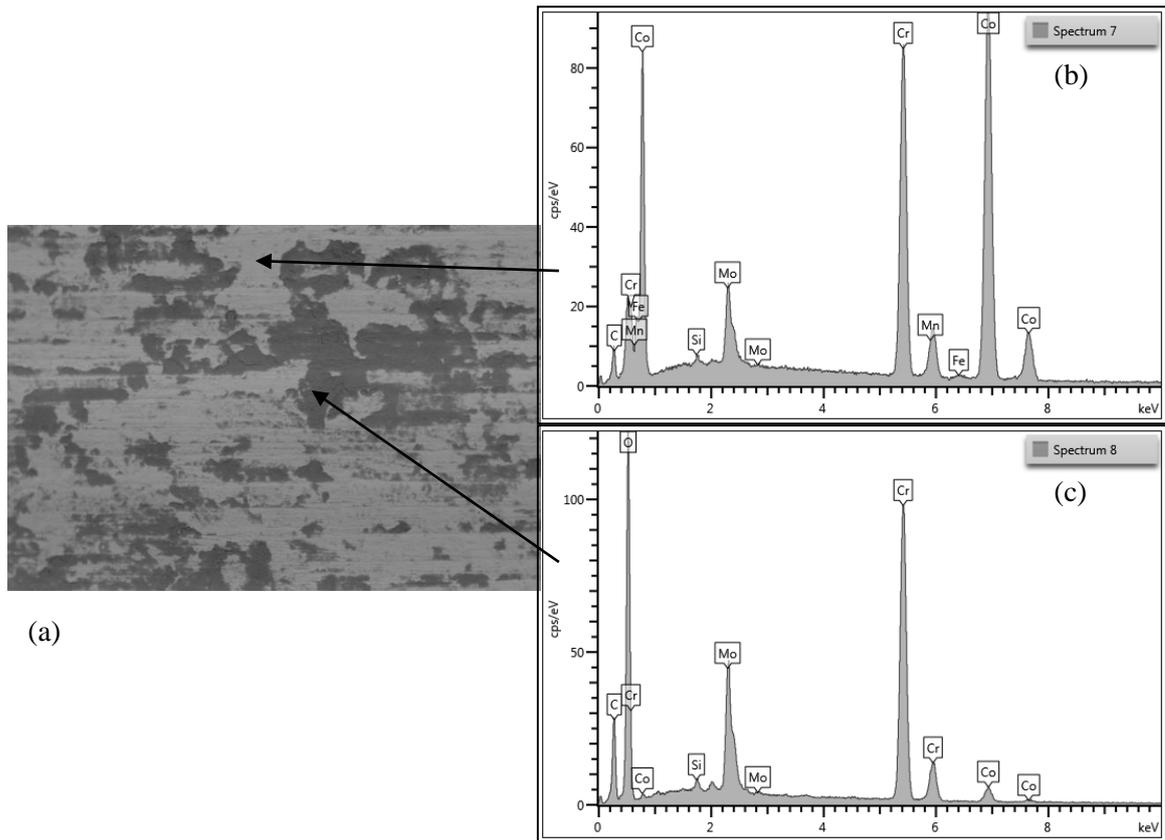
Figure 8-6: (a) SEM image of on sample taper of 1 year explant along with (b), (c) EDX spectrum at various spot
